Experimental Characterisation of Service-Degraded H13 Tool Steel and Numerical Assessment of Die Plasticity Risk in Hot Forging of Nickel-Based Superalloys

Julen Agirre[1,a*], Unai Ibarretxe[1,b], David Abedul[1,c], Nagore Otegi[1,d] and Lander Galdos[1,e]

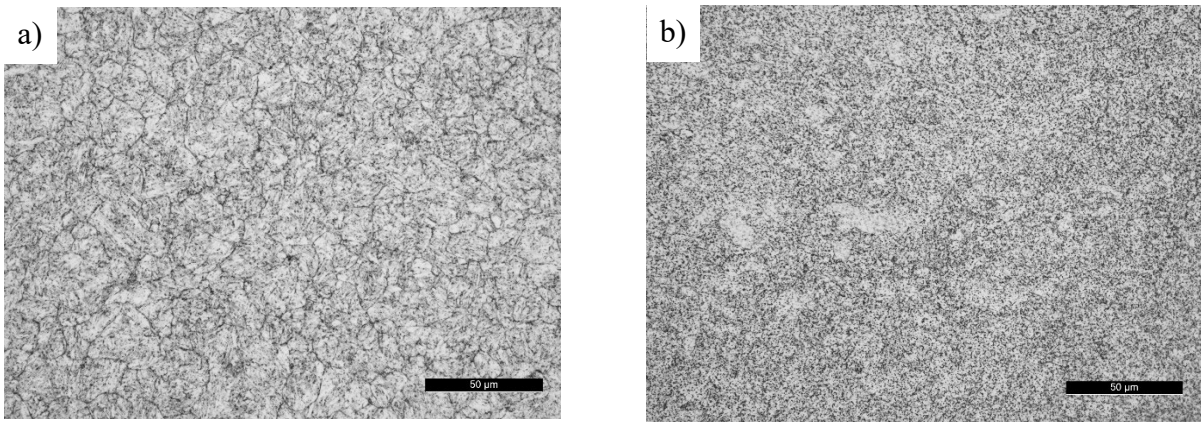
The microstructures of the non-affected zone at the base of the die and the service-degraded zone at the die edge are shown in Fig.7a and Fig.7b, respectively. The microstructure observed in the non-affected zone at the base of the die (Fig.7a) is characteristic of H13 tool steel in the as-heat-treated condition. The microstructure consists of a tempered martensitic matrix with a relatively uniform distribution of fine carbides, indicating that the original quenching and tempering treatment has been preserved in this region.

In contrast, the microstructure observed at the die edge (Fig.7b), corresponding to the most service-degraded zone, exhibits clear signs of thermal degradation. The microstructure appears more homogeneous and less defined, with evidence of carbide coarsening and a reduction in microstructural contrast compared to the base material. This microstructural evolution is indicative of over-tempering caused by prolonged exposure to elevated temperatures and repeated heating-cooling cycles during hot forging. Such changes are consistent with the significant reduction in hardness measured near the die edge.

Fig. 7. a) The microstructures of the non-affected zone at the base of the die; and b) the service-degraded zone at the die edge.

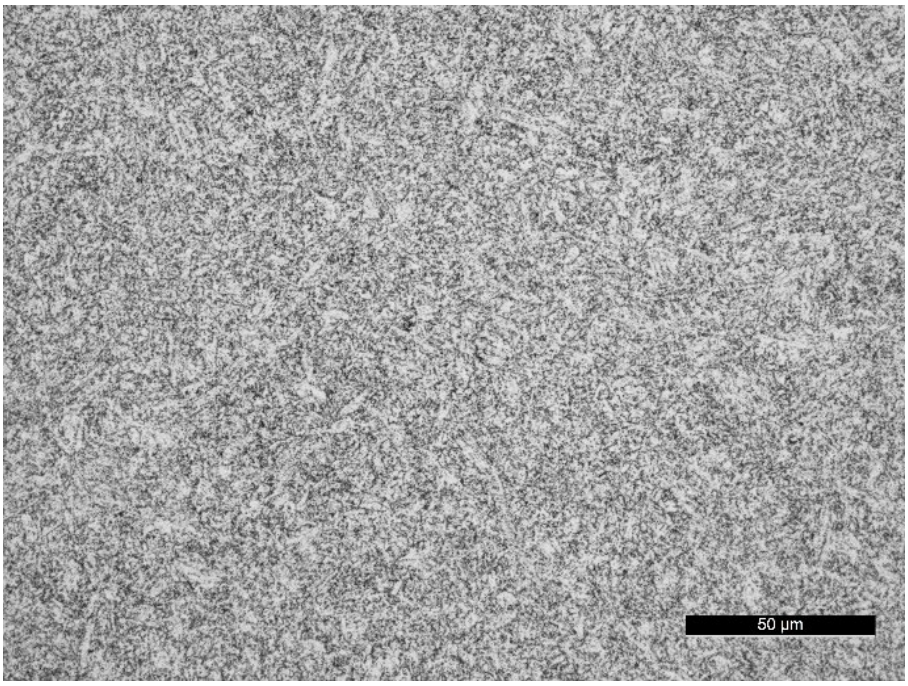
Fig.9 shows the microstructure of the H13 tool steel after the artificial degrading heat treatment. The microstructure exhibits strong similarities to that observed in the service-degraded zone at the die edge, characterised by a tempered martensitic matrix with reduced microstructural contrast and evidence of carbide coarsening. This close correspondence between hardness values and microstructural features confirms that the artificially degraded tensile specimens are representative of the service-degraded state of the industrial die and can therefore be reliably used to characterise the tensile properties of the tool steel after production.

Fig. 9. Optical microstructure of the H13 tool steel in the artificially degraded condition after heat treatment at 650 °C for 10 h.
